Ref: WF 375192

Re: Indicative Fire Resistance Test utilizing the temperature and pressure conditions of BS 476: Part 20: 1987 and the principles of BS 476: 22: 1987 (and current FTSG Resolutions where applicable)

This letter is to confirm the results of an indicative fire resistance test undertaken on 28th October 2016. The specimen consisted of two door leaf sections hung within timber frames.

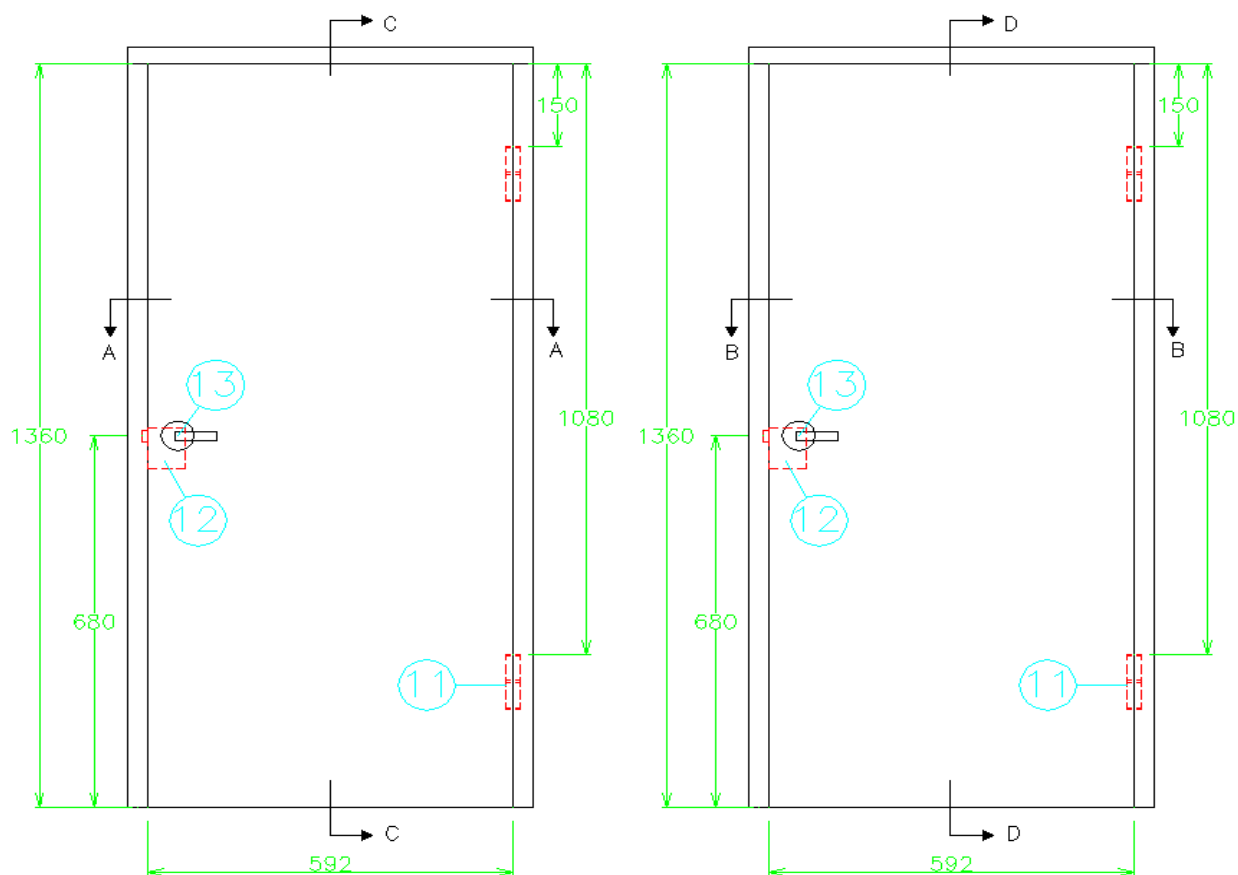
Front elevation showing hardware positions. See page 10 for leaf/frame perimeter gaps.

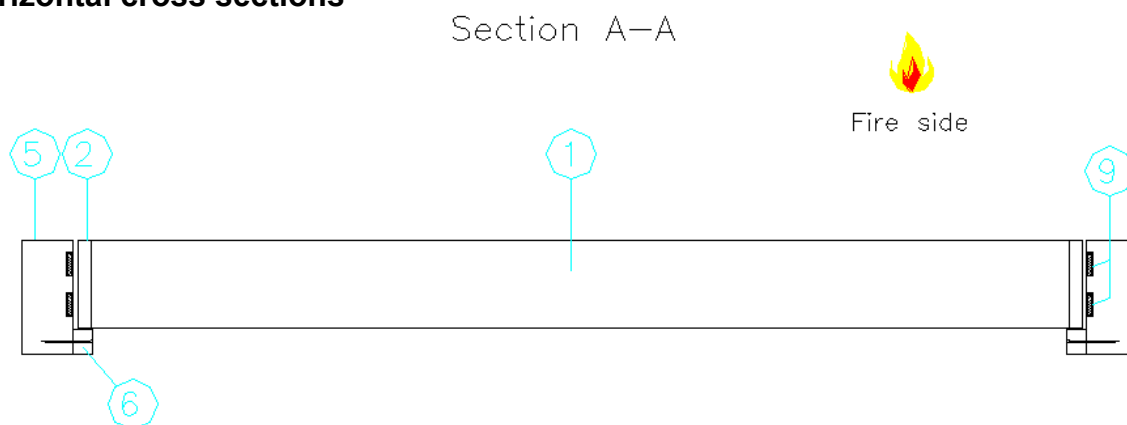
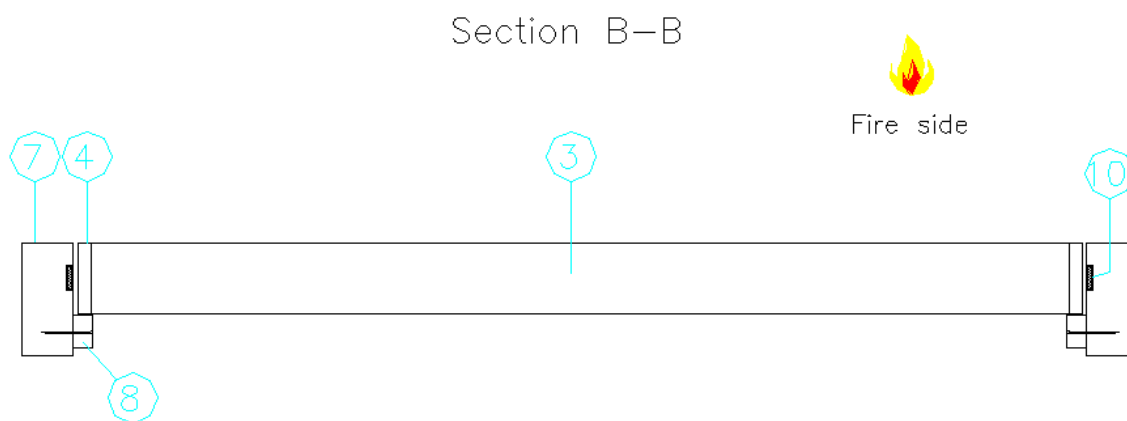
Horizontal cross sections

Species/type	Dimensions (mm)	Density (kg/m ³)	Moisture (% w/w)	Key to figures
Core		Halspan Ltd 3-layer particleboard	54 thick	620±10*	9.9	1
Facings		None fitted	-	-	-	-
Lippings (vertical edges only)		Sapele	8 thick	640**	8.3	2
Adhesive	Lippings	PU	-	-	-	-

Species/type	Dimensions (mm)	Density (kg/m ³)	Moisture (% w/w)	Key to figures
Core		Halspan Ltd 3-layer particleboard	44 thick	620±10*	9.8	3
Facings		None fitted	-	-	-	-
Lippings (vertical edges only)		Sapele	8 thick	640**	7.8	4
Adhesive	Lippings	PU	-	-	-	-

Material	Dimensions (mm)	Density (kg/m ³)	Moisture (% w/w)	Key to figures
Frame	Head and jambs	Sapele	70 deep x 32 thick	640*	7.8	5
	Threshold	Non combustible	-	-	-	-
Frame jointing detail		Mortice and tenon - screwed	-	-	-	-
Stop – planted (pinned)		Sapele	12 thick x 15 wide	640*	9.1	6
Frame to supporting construction fire stopping detail		Tightly packed rock mineral fibre capped with intumescent acrylic mastic on the exposed face	Nominally 5-10mm wide x 10-15 deep	-	-	-
Frame fixing method		Steel wood screws – 3No. per jamb	80 long	-	-	-

Material	Dimensions (mm)	Density (kg/m ³)	Moisture (% w/w)	Key to figures
Frame	Head and jambs	European Redwood	70 deep x 32 thick	510*	7.7	7
	Threshold	Non combustible	-	-	-	-
Frame jointing detail		Mortice and tenon - screwed	-	-	-	-
Stop – planted (pinned)		European Redwood	12 thick x 20 wide	510*	8.4	8
Frame to supporting construction fire stopping detail		Tightly packed rock mineral fibre capped with intumescent acrylic mastic on the exposed face	Nominally 5-10mm wide x 10-15 deep	-	-	-
Frame fixing method		Steel wood screws – 3No. per jamb	80 long	-	-	-

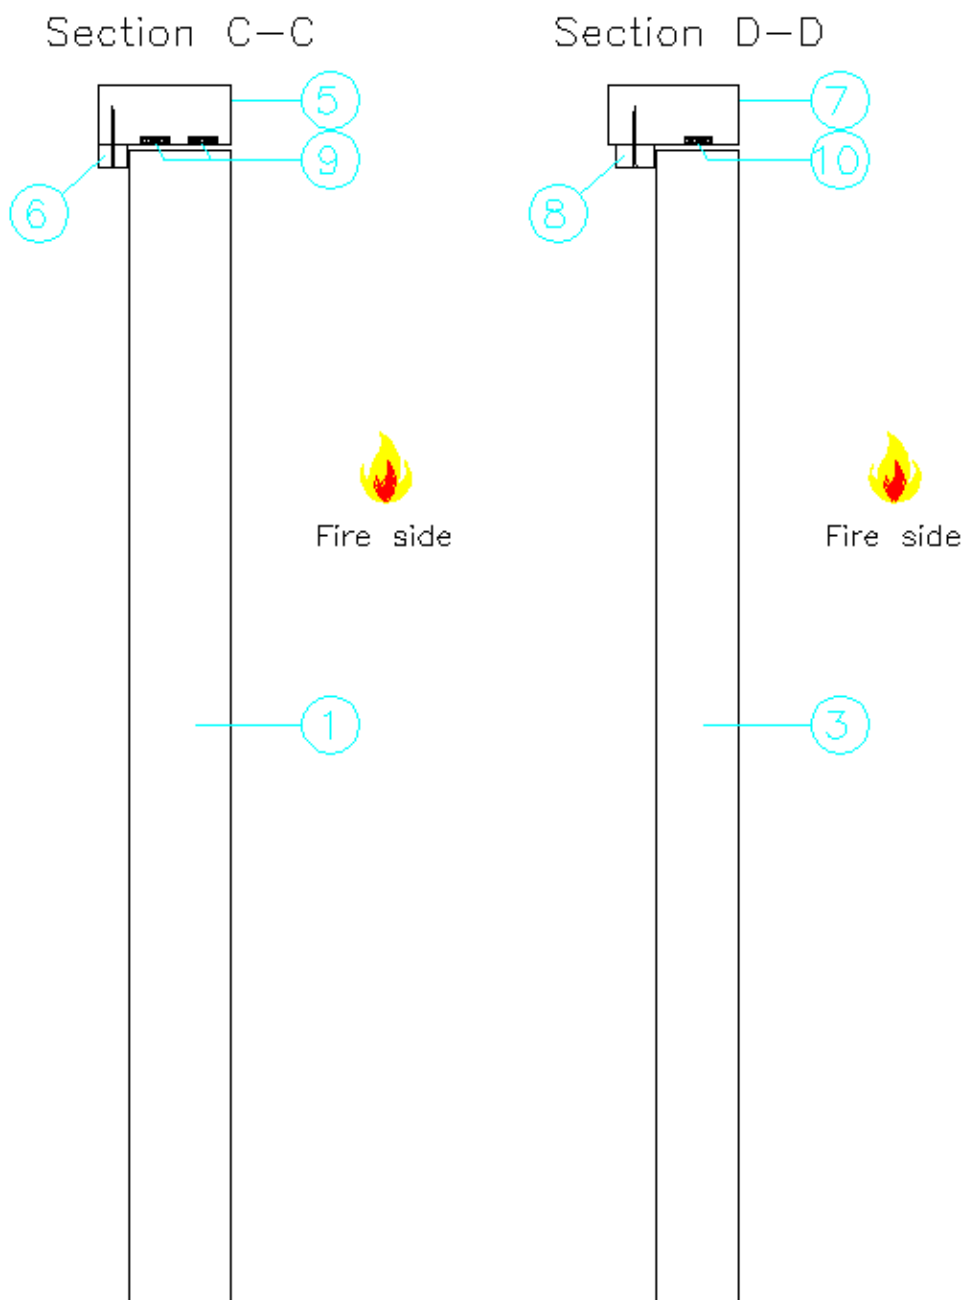
Vertical cross sections

Make/type	Size (mm)	Location	Key to figures
Leaf edge	None fitted	-	-	-
Frame reveal – head and jambs	2No. Pyroplex Rigid Box Seals FO8700	15 x 4	Fitted 10mm apart, 7mm from the exposed face in the frame reveal	9

Make/type	Size (mm)	Location	Key to figures
Leaf edge	None fitted	-	-	-
Frame reveal – head and jambs	Pyroplex Rigid Box Seal FO8700	15 x 4	Fitted 14mm from the exposed face in the frame reveal	10

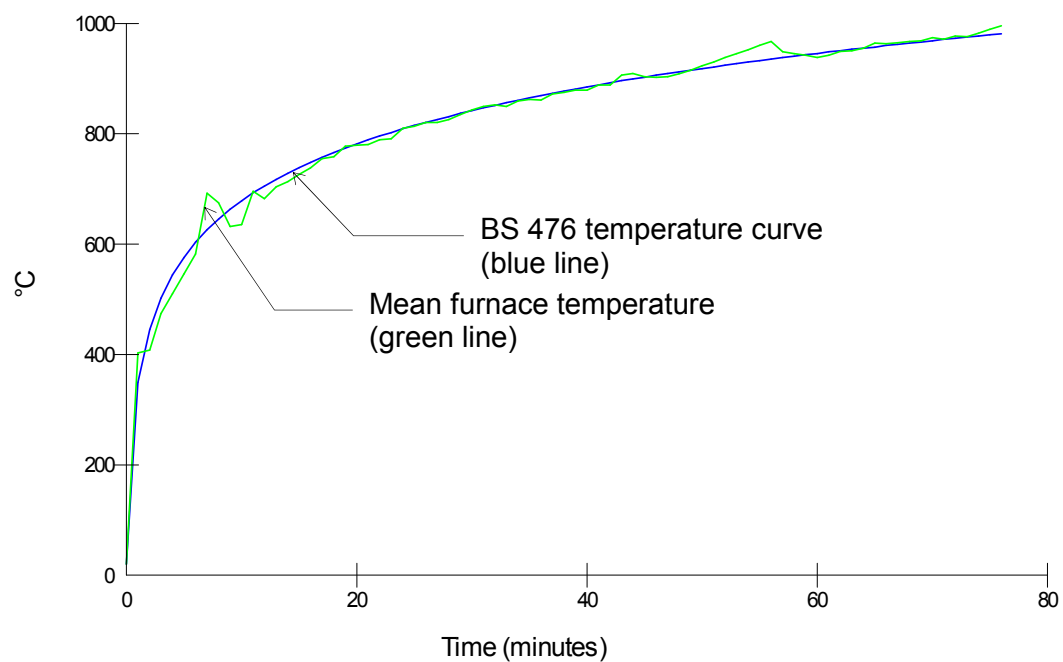
Furnace temperature curves

The furnace temperature was measured using the average of 5No furnace thermocouples. The temperature and pressure were controlled to the conditions outlined in BS 476: Part 20: 1987.

The furnace pressure was maintained at 2.55Pa with respect to atmosphere, to replicate a door handle height of 1000mm from the leaf threshold.

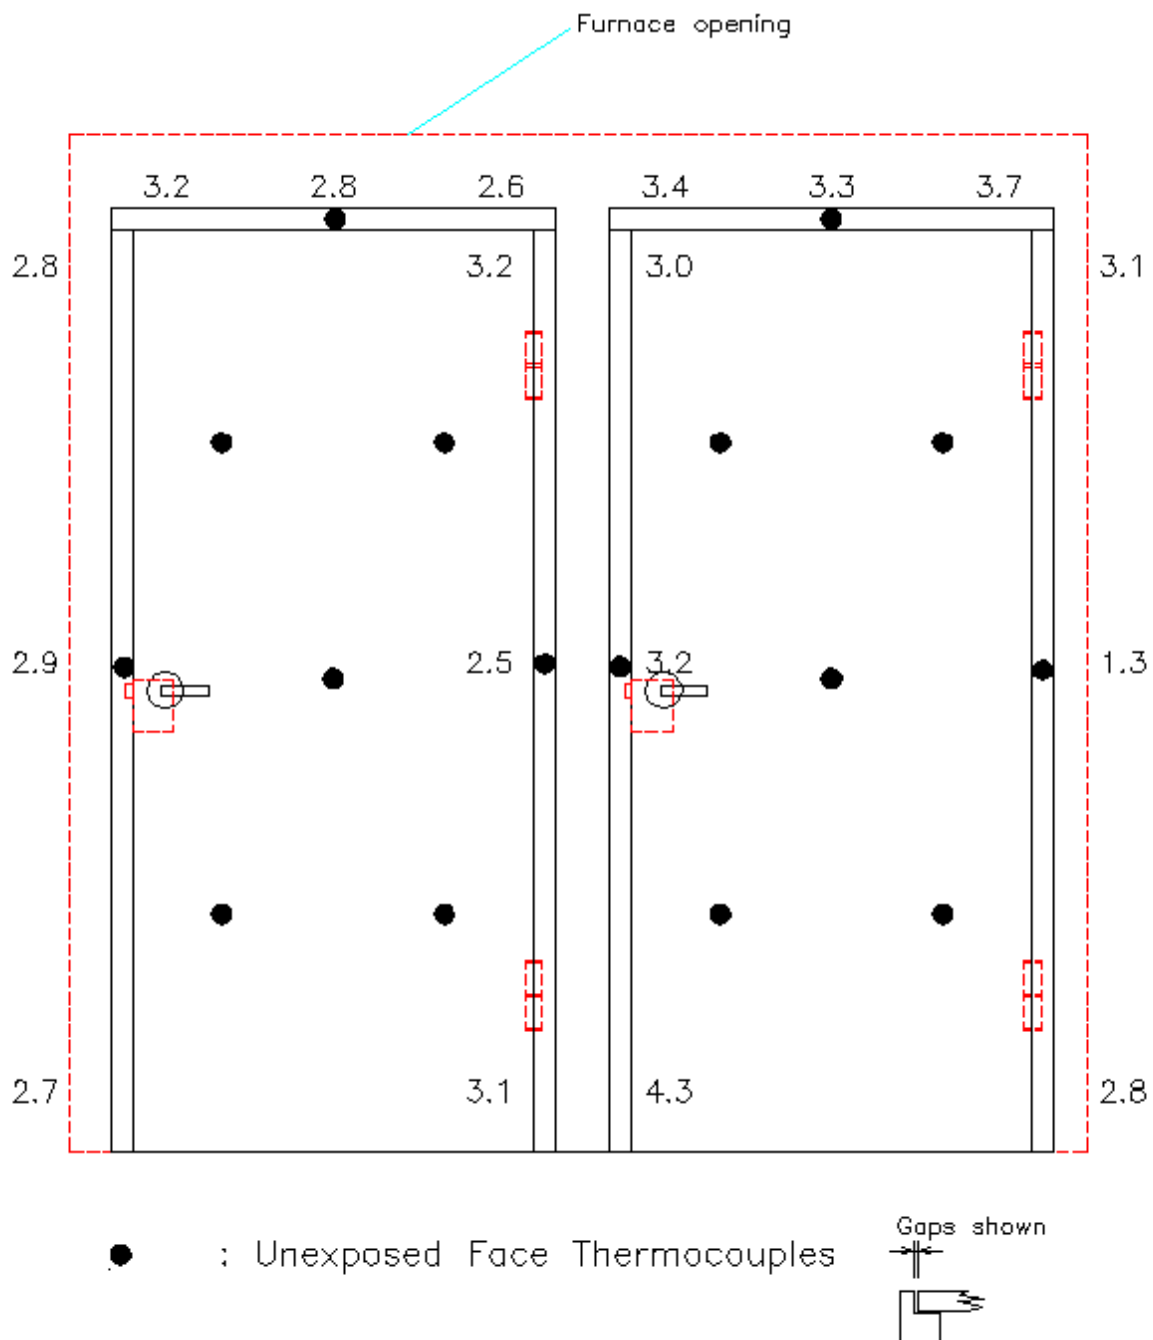
Unexposed face thermocouples and leaf edge perimeter gaps

The temperature of the unexposed face of each doorset was monitored by means of five thermocouples fixed to the leaf face, and three thermocouples fitted to the frame, one at mid height on each frame jamb and one centrally located above the leaf on the frame head. The locations of the thermocouples are shown below. The temperatures recorded are shown graphically overleaf.

The door leaf edge perimeter gaps were measured prior to test. The recorded measurements are shown below.

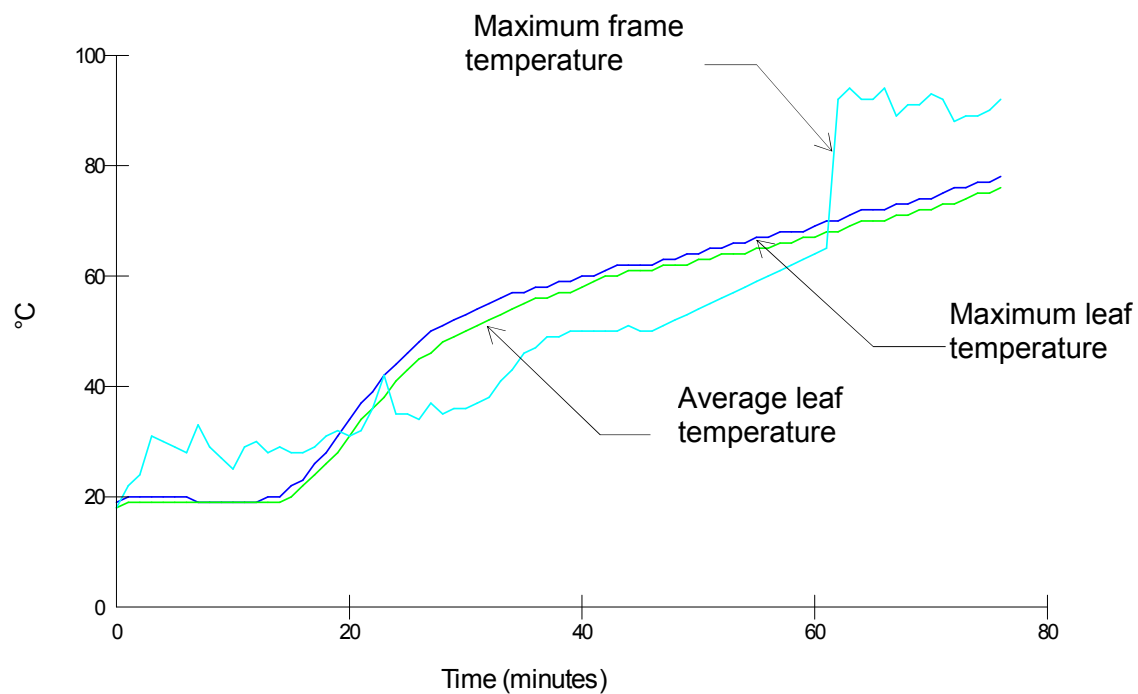
Doorset A

Unexposed face temperature curves

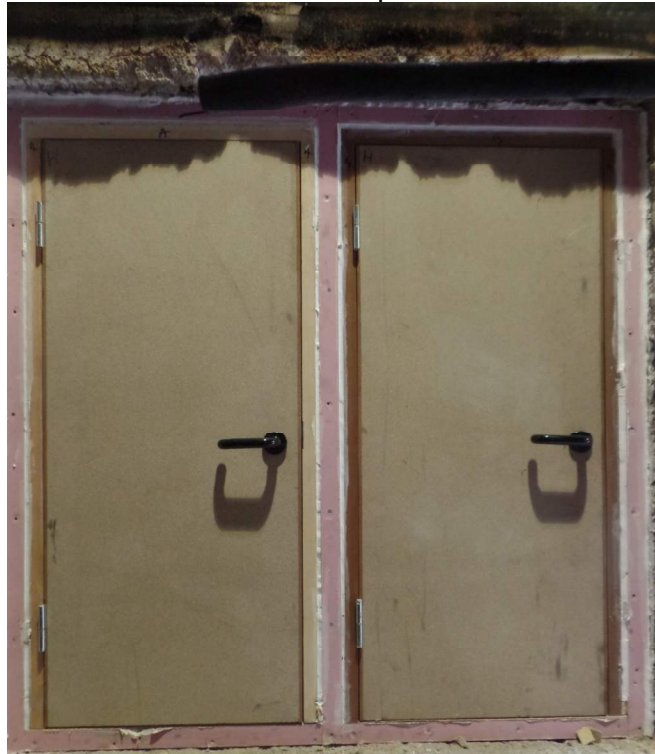
Titan Healthcare Products antibacterial handle – exposed face

06.31	Doorset B, there is smoke issuing at the top hanging edge.
07.08	Doorset B, there is discoloration at the top closing edge.
07.20	Exposed face, both doorsets, the plastic coating on the handles has melted away leaving steel exposed.
